Safety Alert

Issue: Near Miss

Location: Maintenance Shop #7

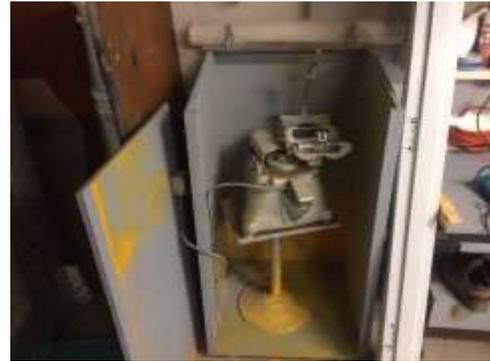
On Tuesday, July 10, a painter was mixing four (4) aerosol cans of Rust-Oleum Striping (Line) Paint using the paint shaker. The cans dislodged and fell to the bottom of the shaker, puncturing one of the cans. The cans could not be removed without dismantling the shaker. Four more cans were placed on the shaker, and when the painter turned the machine back on, there was a blue flame and a swooshing noise (described as similar to lighting a barbecue with the cover closed). The painter grabbed a fire extinguisher, but the fire had already extinguished itself.

The Rust-Oleum Striping Paint is a highly flammable paint, and the electricity in the paint shaker ignited the gases from the punctured paint can at the bottom of the machine.

- Aerosol paint cans shall not be shaken using the paint shaker. This type of paint shall be mixed as per the directions on the can.
- Workers using the Striping paint (and any WHMIS-controlled products) shall read and understand the safety data sheet prior to using the product.
- A safe work practice / job procedure will be developed for using the paint shaker, and all users will be trained prior to using the shaker.
