Safety Alert

Issue: Incident

Location: MacNeil House

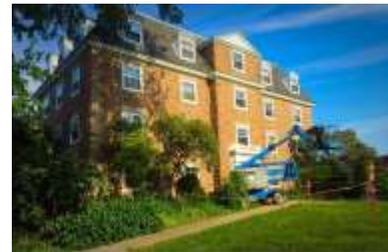
On Friday, July 6th, two carpentry workers were elevated in a Genie “Zoom Boom” work platform, when they felt the basket drop approximately one foot. They immediately informed their supervisor, a safe rescue was performed, and the workers were returned to the ground unharmed. Upon inspection of the base of the unit, it was noted that one wheel was approximately six inches off the ground, and the machine was on uneven ground.

- A workplace inspection shall be performed by all operators in conjunction with the pre-operation inspection, prior to using the zoom boom.
- Do not raise or extend the boom unless the machine is on a firm, level surface. Do not depend on the tilt alarm as a level indicator. The tilt alarm sounds in the platform only when the machine is on a severe slope.
- If the tilt alarm sounds: Do not extend, rotate or raise the boom above horizontal. Move the machine to a firm, level surface before raising the platform. If the tilt alarm sounds when the platform is raised, use extreme caution to retract the boom and lower the platform. Do not rotate the boom while lowering. Move the machine to a firm, level surface before raising the platform.
