February 1, 2022

Project #28925

RE: Total Airborne Mould Spore Sampling, Nicholson Tower, St. Francis Xavier University.

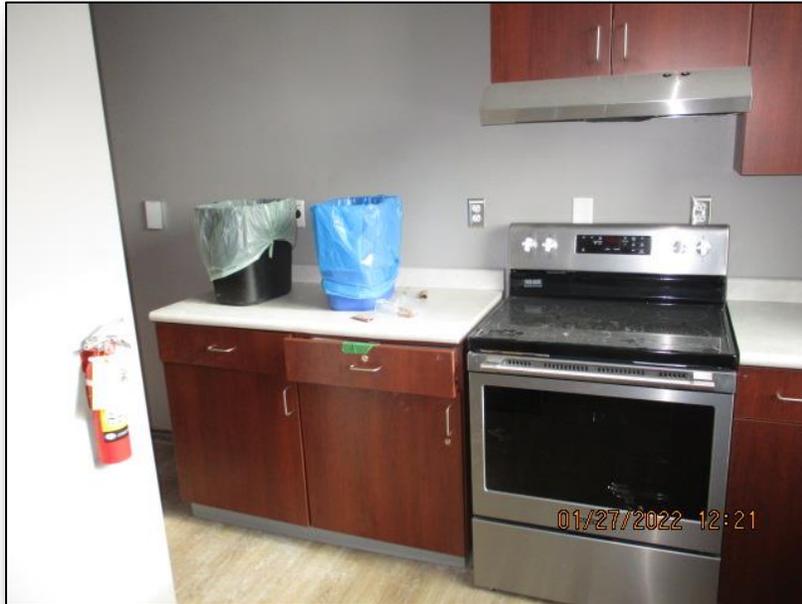
On January 27, 2022, ALL-TECH Environmental Services Limited (ALL-TECH) was contracted by St. FX University to conduct total airborne mould spore sampling in Nicholson Tower. The purpose of the sampling was to determine total airborne mould spore concentrations after clean-up of a flood occurred on January 16, 2022, in the Pantry, Rm 822 on the 8th floor. The sample locations were randomly selected by ALL-TECH. the flooding was caused by a ruptured domestic cold-water line (Category 1 – clean water).

Photo 1 - Location of water leak, Rm 822, Pantry

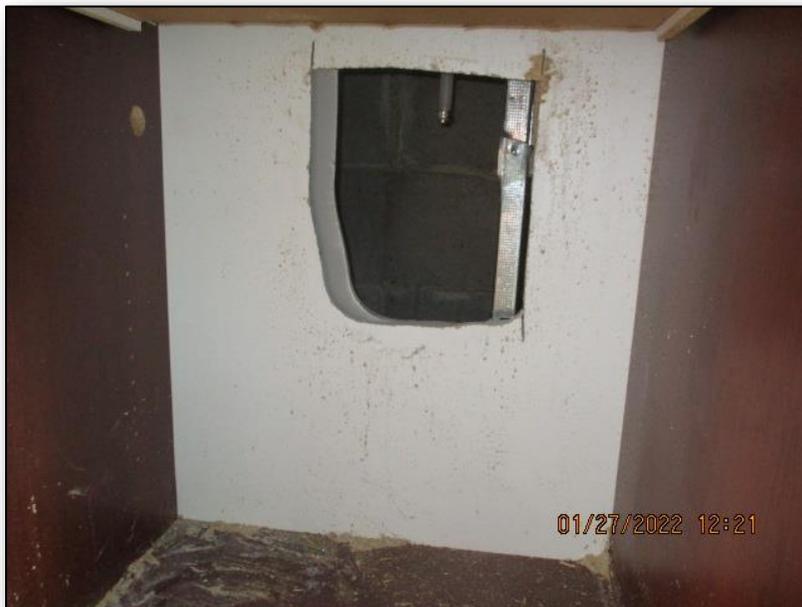
Photo 2 - Ruptured domestic cold water line causing leak, Rm 822, Pantry.
